Ceramic Coating of Superheater Tubes and Extended Experiences in WtE Boilers as Alternative to Nickel-based Protection

Ildefonso Goikoetxea and Eddie Marcarian

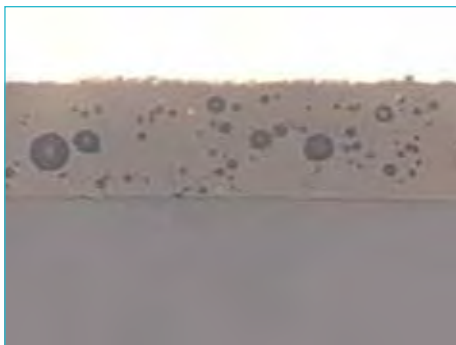
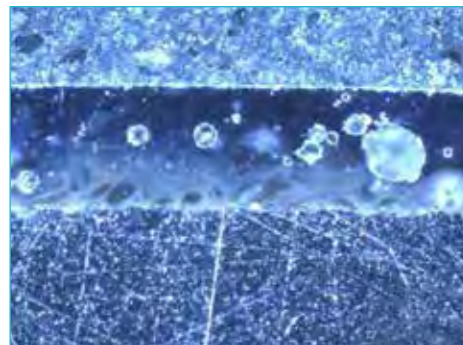
Figure 1: Structural view

Ceramic coating

Typical coating

- thickness range: 100-200 μm ,
- hardness: 64 HRC,
- elongation: max 1.2 %,
- roughness: Ra: 0.04 microns; Rz: 0.2 microns.

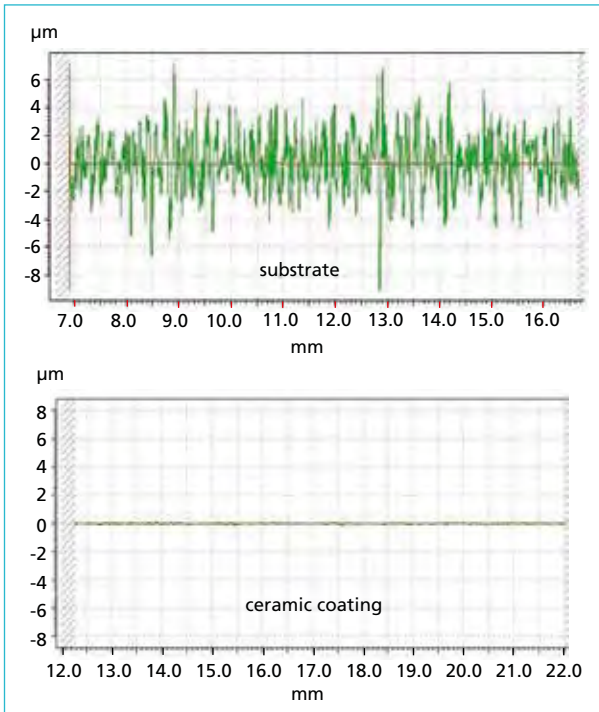
Figure 2:
Coating surface

- Thermal conductivity: 6 Watt/mK at 600 °C

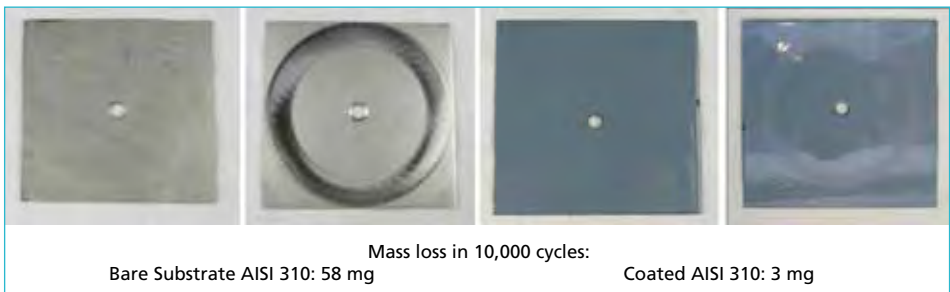
Figure 3: Abrasion test

Abrasion resistance

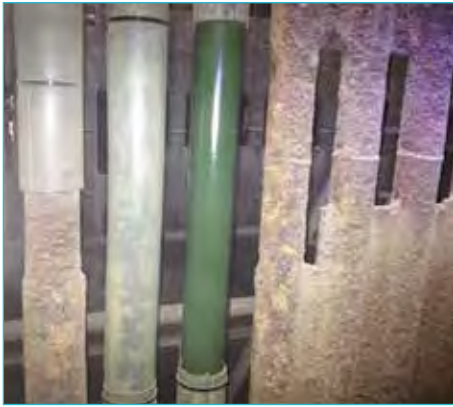
Figure 7: Tubes plastic protection

Plastic protection covers for shop and inside boiler operations

These covers resist perfectly the burning particles thrown away by grinding discs or during welding. They also resist conventional shot blasting aimed for bare steel tubes. Ceramic-coated tubes can be easily cleaned by water jet.

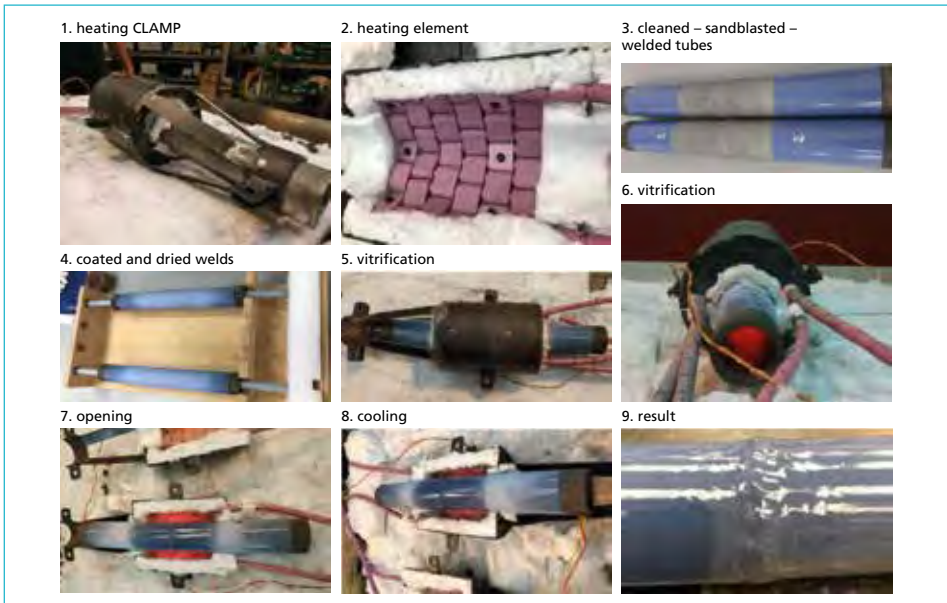
Figure 8: Weld treatment – on site coating and vitrification of welded joints and eventual defects

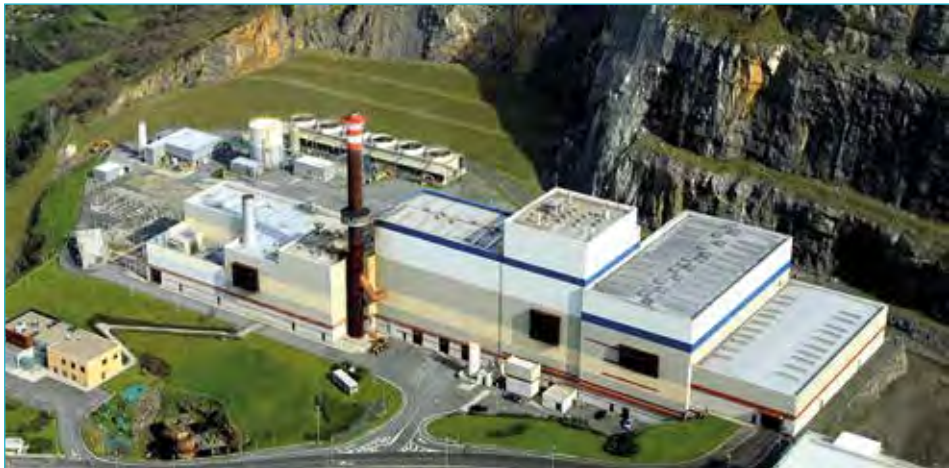
Figure 9: Area of WtE integrated in Artigas-Arraiz Special Plan in Bilbao

The Zabalgarbi urban waste-to-energy system is an industrial process that adapts the technology of combined-cycle gas plants to modern waste-to-energy facilities. The plant has been supplied and delivered in 2005.

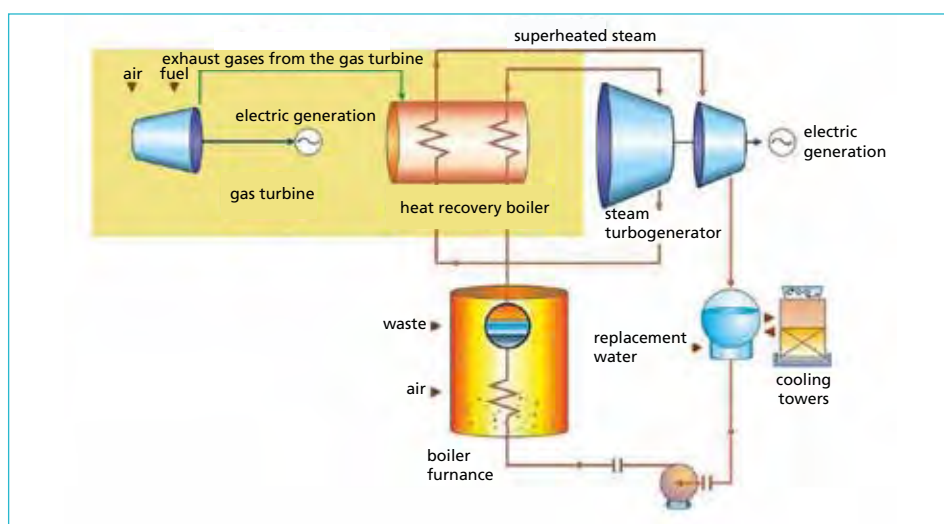
In the incineration boiler slight superheated steam at a temperature of 328 °C and a pressure of 106 bar is produced in Zabargarbi's incineration-line furnace-boiler. One line with the nominal capacity of the WtE package is 30 t/h of waste for a thermal heat yield of 70,8 MW.

Figure 10: Schematic process diagram

This saturated steam from the furnace-boiler is superheated to 540 °C in a recovery boiler using heat from the flue gases of a 43 MW gas turbine (GE LM6000), while maintaining pressure at 100 bar in conditions similar to those of a power plant using conventional fuels.

The superheated steam is used to drive a 56.5 MW turbo-generator (GE Nuovo Pignone). Gross power yield is 99.5 MW, and the net output after the plant's own consumption is 94 MW.

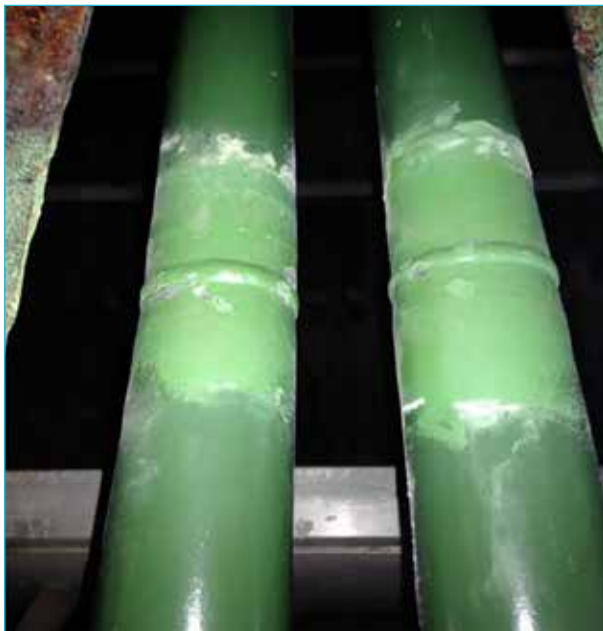
Figure 12:

Tubes coating aspect of ceramic application on site (welding parts)

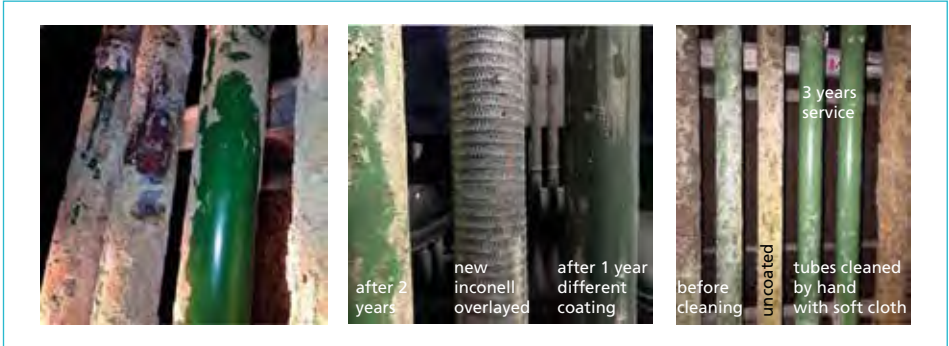
After *one-year* operation, the tubes were always brand new; ash was easily removed by hand as it was probably deposited by condensation at the cooling of the boiler and not in hot operation. The *glossy surface* indicates that not a single micron of coating has been neither eroded nor corroded during the year. The same still happens after three years operation.

Figure 13: Tubes after one year and after three years before and after cleaning the ash by hand with a glove

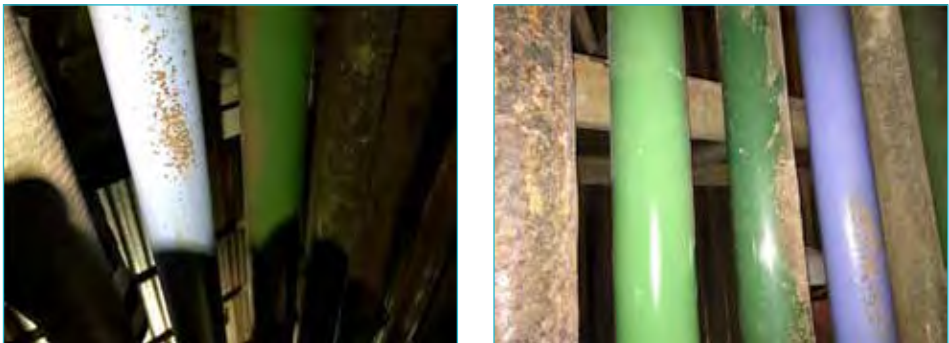
The results are always satisfactory without losing material and without any thickness reduction. Nevertheless, it was detected that sand blasting done last year (2017) without protecting tubes is harmful for the coating.

Figure 14: Tubes after four years with different ceramic quality after cleaning and some attacked tubes due to sand blasting last year without cover

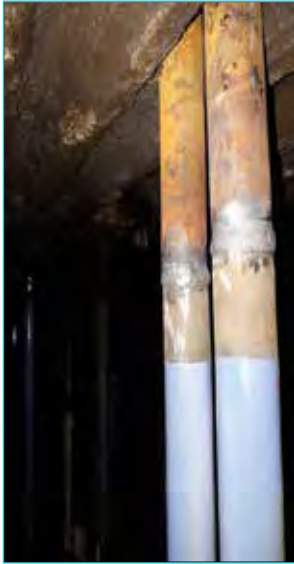
Figure 16: Tubes installation

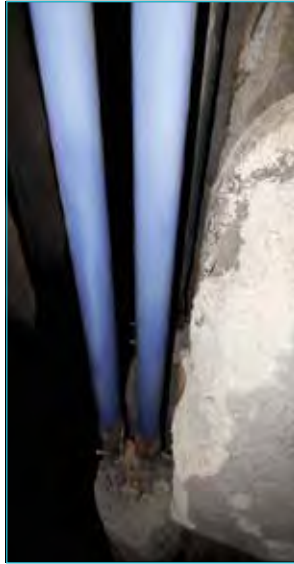
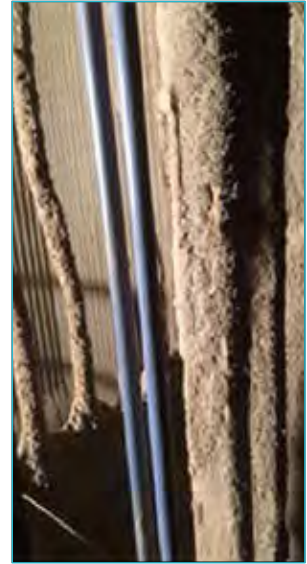
After six months of continuous operation, the result seem very interesting, as no fouling was stuck on the tubes, and the coating was brand new.

Figure 17: Tubes after six months

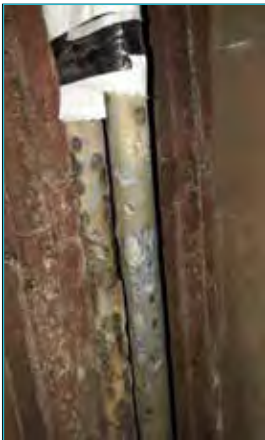
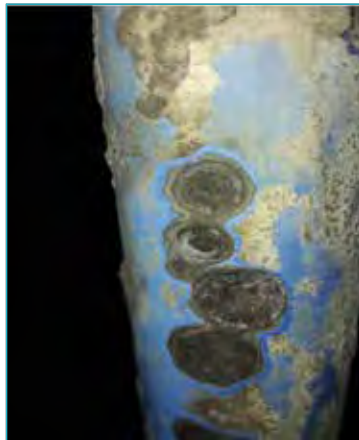
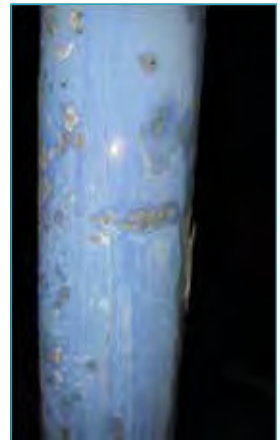
After one year of operation, it was finally possible to enter in the boiler and inspect the coated tubes.

Figure 18: Tubes after one year with attack signs

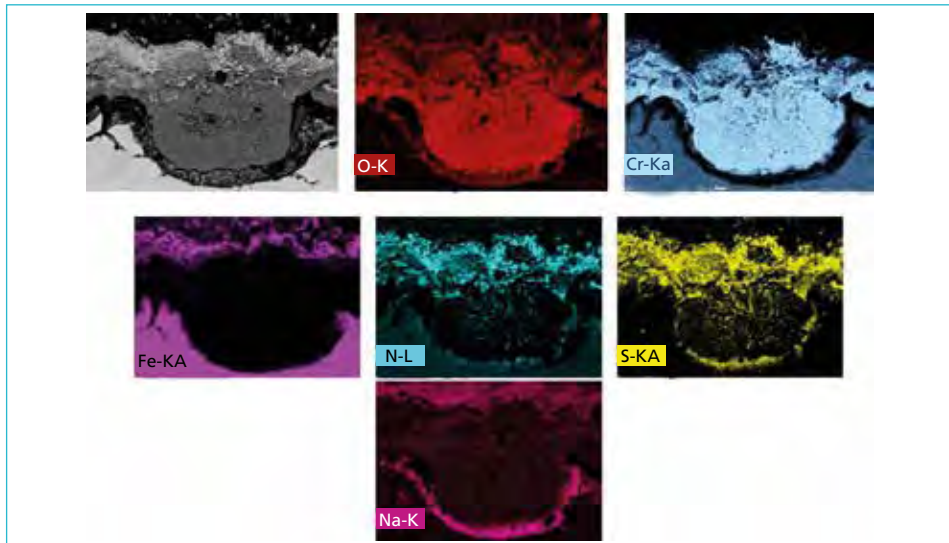
EDS Mappings were performed in several pits with corrosion deposits to determine the concentration of several elements like Cl, Na, K, S etc. It is supposed that localized corrosion is caused by sulfidation/oxidation and/or chlorination attacks.

Figure 20: EDS Mapping of corrosion products rich in Na and S

In Figure 20, different layers/compounds have been detected: on top, Iron rich compound, and consequently Ni and S, then a Chromium rich oxide and finally a Na rich compound.

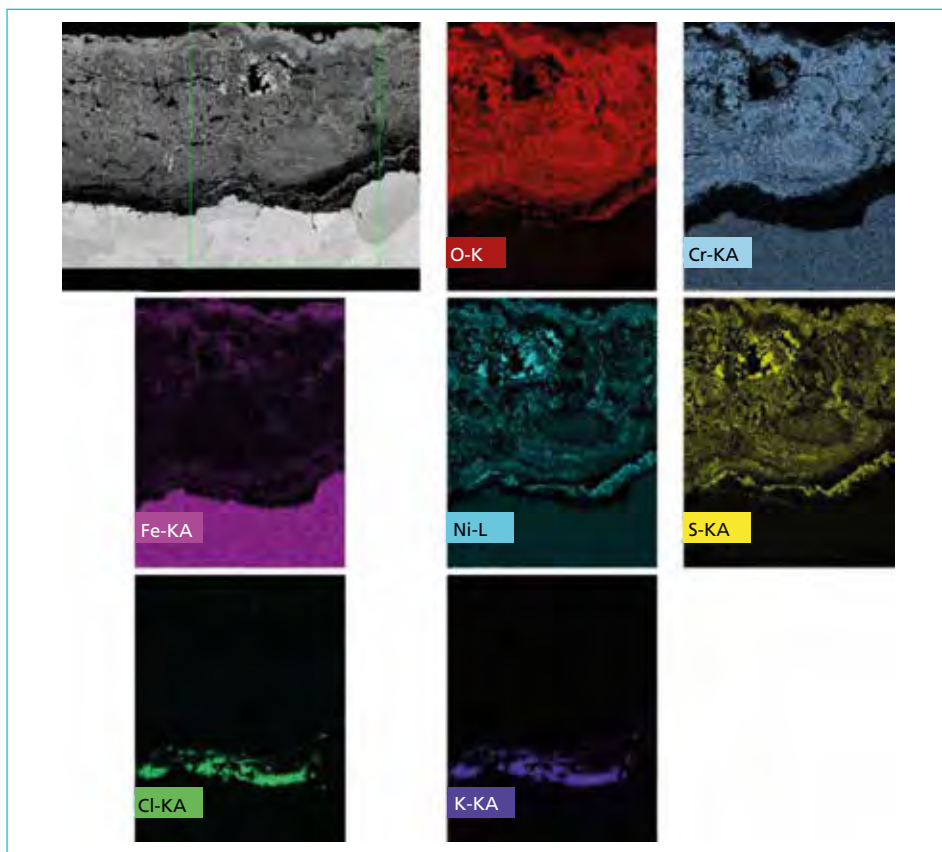
In other analyzed area (Figure 21), again Cr oxides and Fe-Ni-S are present but instead of Na rich compounds, Cl and K have been detected.

Figure 21: EDS Mapping of corrosion products rich in Cl, K and S

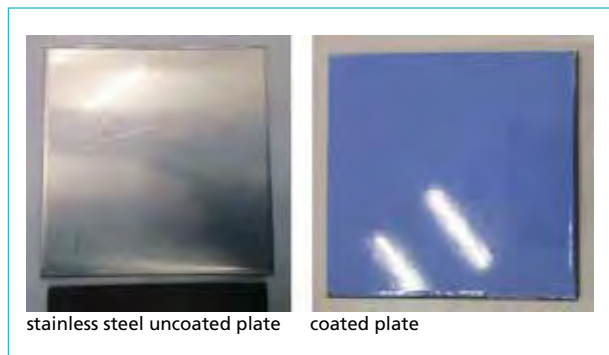
Figure 22:

A small amount of white ashes and lentil milled ashes, were placed over the surface of one uncoated stainless steel plate and one coated plate (Figure 22).

Stainless steel uncoated and coated plates before the laboratory test

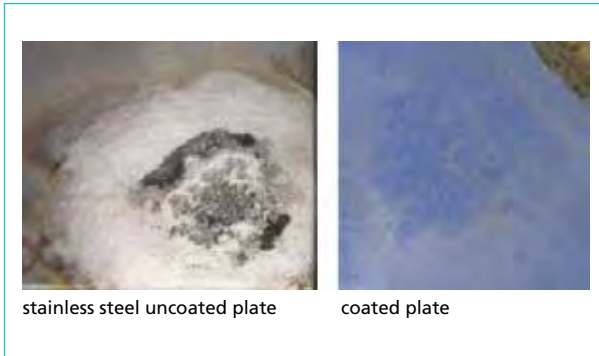
Figure 23:

These plates were placed inside a furnace for one hour (Figure 23). As a result, the uncoated sample presents a chemical attack and weight loss, and the coated one experienced a slight attack with only loss on brightness.

Uncoated and coated plates after 1 hour at 600 °C in a laboratory furnace

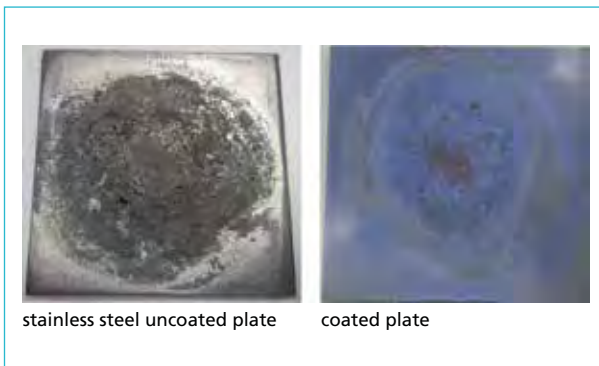
Figure 24:

After 96 hours (Figure 24), stainless steel presents a significant weight loss and a change in color and a loss on brightness can be observed in the coated sample.

Uncoated and coated plates after 96 hours at 600 °C in a laboratory furnace

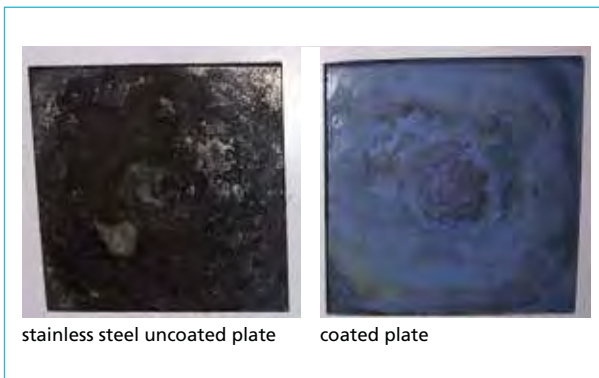
Figure 25:

After 150 hours (Figure 25), an important attack is observed for stainless steel but it can be observed how the ashes begin to remain attached to the coated surface.

Uncoated and coated plates after 150 hours at 600 °C in a laboratory furnace

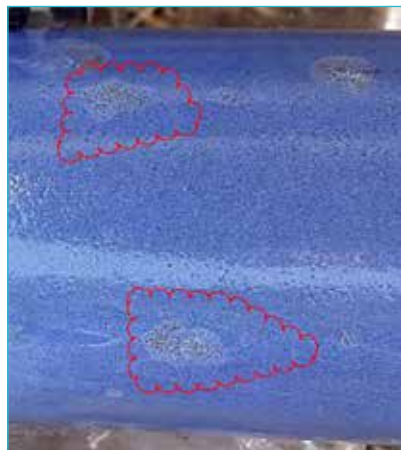
Figure 26: Crack or spalling on ceramic coating

- handling by hand (marks),
- spraying by hand – *very irregular coat thickness* (only 20 microns for some parts),
- dust in the ambience (sticken dust creates worm holes to the substrate and was the initiation of the *pitting* corrosion (the black dots) apart from scratches and other handling defects), and
- inadequate furnace (vitrified 200 Kgs of tube (12 min) in a furnace designed to quench 40 Mt during 20 hours).

These tubes showed coating thickness variations and black dots, mainly coming from floating dust of sand and oxides in a big cast Iron foundry shop.

Better results are foreseen in the new set of samples being prepared by Tubacoat as ceramic layer homogeneity and dust control will be controlled through the new manufacturing line and control process.

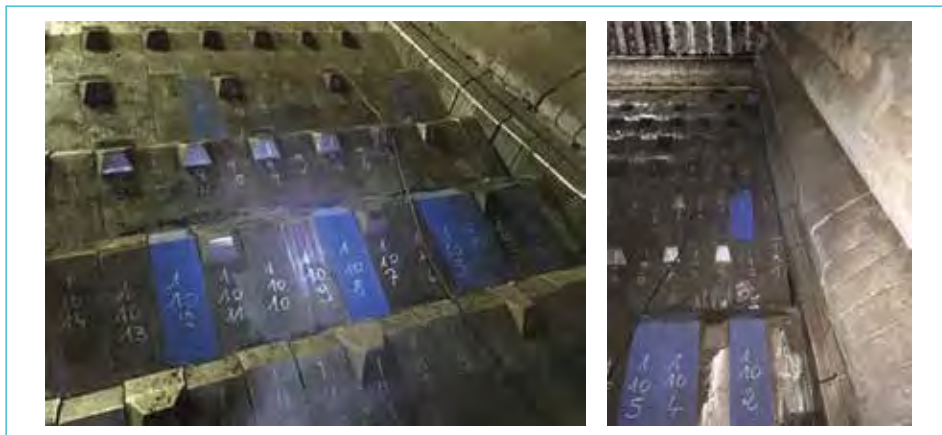
This test is performed in Zabalgardi plant.

Figure 27: Grate bars application

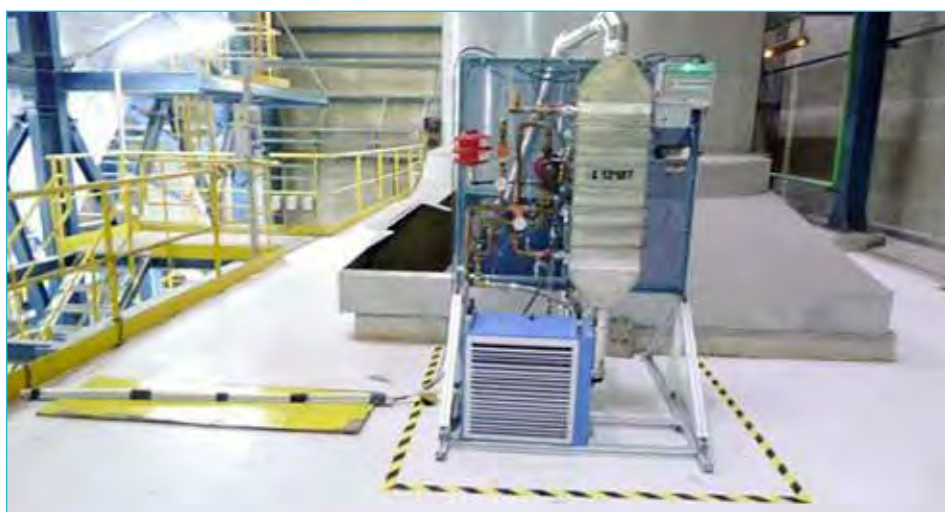
Figure 28 shows the design of the condenser.

Figure 28: 5 kW fume condenser prototype at an urban waste power plant

A 5 kW prototype has been successfully tested in Zabalgardi with gases after bag house filter. The target of this new heat exchanger made of internally ceramic coated carbon steel tubes has been to:

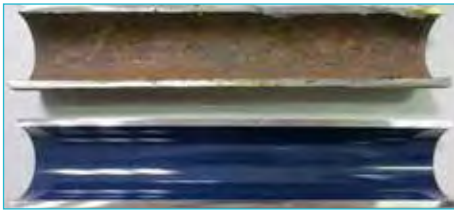
After six months working in real conditions, the aspect of the tubes coated and bare are shown in Figure 29.

Figure 29: Coated/non coated elements from the condenser
